***Live Oak No. 2  
Community Development  
District***

**September 17, 2026**

**Agenda Package**

**i. Consideration of Phase 2B Littoral Shelf Evaluation and Planting Recommendation Ponds 12-1, 12-2, 12-3 and 13-1**

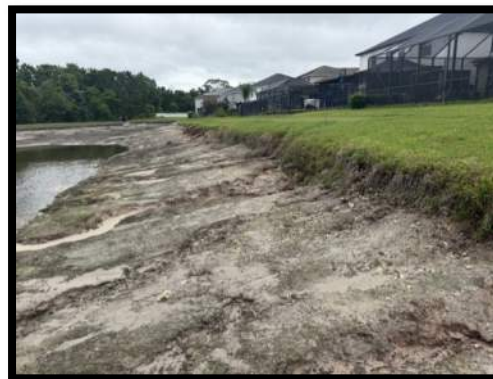
**Photo 121-10**

- Water levels were approximately 7ft below the design SHW (see Photo 121-10 below for visual reference).
- An abrupt vertical drop/lip, ranging in height from 12" to 18" or more, is present around the entire perimeter of the pond (see Photo 121-10 below for visual reference).

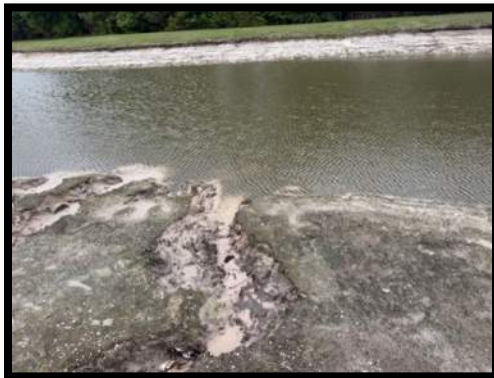
**Photo 121-06**

- Visual evidence of persistent damaging erosion along the eastern edge of the pond (behind homes). Concentrated runoff has carved rills/channels into the exposed pond bottom, indicating water levels have been low for an extended period of time (if at SHW, the water would absorb the energy from the runoff and would not scour/carve the pond bottom). Refer to Photos 121-06, 121-08, 121-26, 121-27, and 121-28 below. All instances of this condition are on the eastern bank of the pond (behind homes).

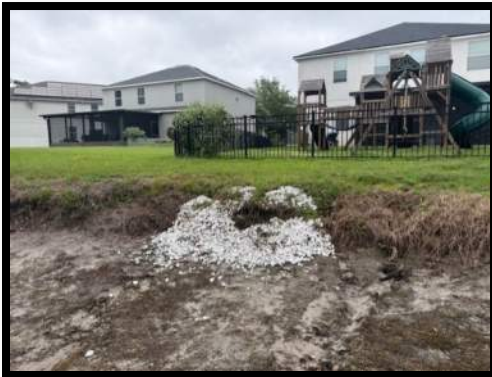
**Photo 121-01**

- Multiple locations of severe erosion and bank failure/sloughing on eastern bank. Home owners have implemented temporary repair measures (gravel, rock, sod blankets, etc.) in several locations in an attempt to stabilize the bank. These locations appear to align with areas between the homes, where runoff may be concentrated by lot grading before spilling over the lip into the pond. See Photos 121-01, 121-11, 121-14, 121-22, 121-23, and 121-25 below for a visual reference.

**High Priority** – at these locations, the bank has been destabilized and is in various stages of sloughing, degradation, and distress. Voids have formed and progressed towards homes. In several instances, homeowners have attempted to halt the process with ad hoc repairs (gravel, erosion blankets, grass clippings, soil material, etc.). To properly address these areas and prevent continued erosion problems:

- Bank material should be removed to a horizontal distance from the lip equal to four times the drop height at that location to a depth equal to the drop height, or until all damaged/destabilized material has been removed – whichever distance is greater. For example, if the drop height at the lip is 1ft, the bank face should be excavated 1ft vertically from surface to a distance of 4ft beyond the lip/face. The horizontal distance from the lip face to the extent of the landward excavation shall be designated “X” for this discussion.

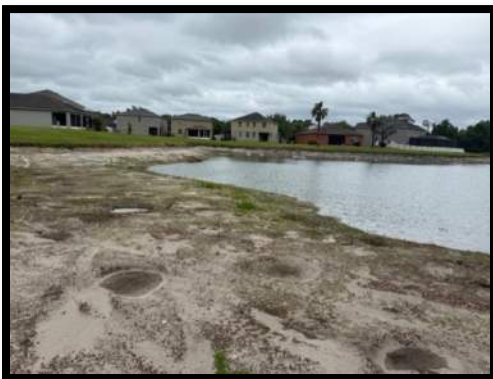
**Photo 122-40**

- Water levels were approximately 6ft below the design SHW (see Photo 122-40 below for visual reference).
- An abrupt vertical drop/lip, ranging in height from 12" to 18" or more, is present around the entire perimeter of the pond (see Photos 122-43 and 122-44 below for visual reference).

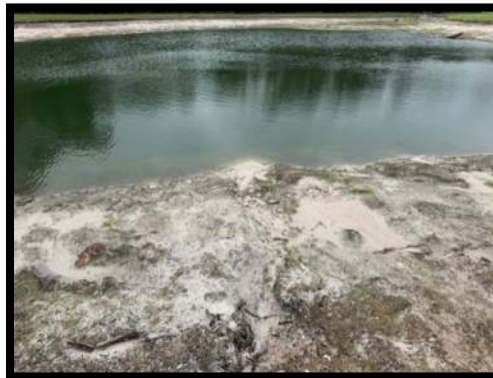
**Photo 122-14**

- Visual evidence of persistent damaging erosion along the western edge of the pond (behind homes). Concentrated runoff has carved rills/channels into the exposed pond bottom, indicating water levels have been low for an extended period of time (if at SHW, the water would absorb the energy from the runoff and would not scour/carve the pond bottom). Refer to Photos 122-14, 122-16, 122-17, 122-19, and 122-35 below. All instances of this condition are on the western bank of the pond (behind homes). The “corner” area on the western bank is in danger of collapse (Photo 122-57 below).

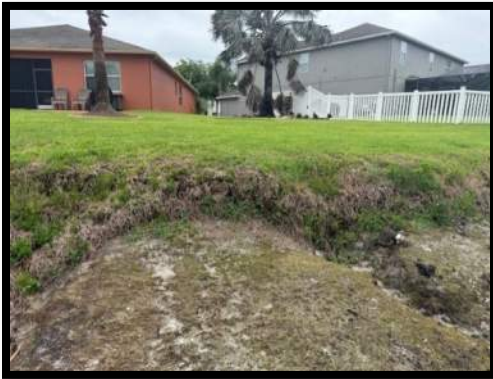
**Photo 122-03**

- Multiple locations of severe erosion and bank failure/sloughing on western bank. These locations appear to align with areas between the homes, where runoff may be concentrated by lot grading before spilling over the lip into the pond. See Photos 121-01, 121-11, 121-14, 121-22, 121-23, and 121-25 below for a visual reference.

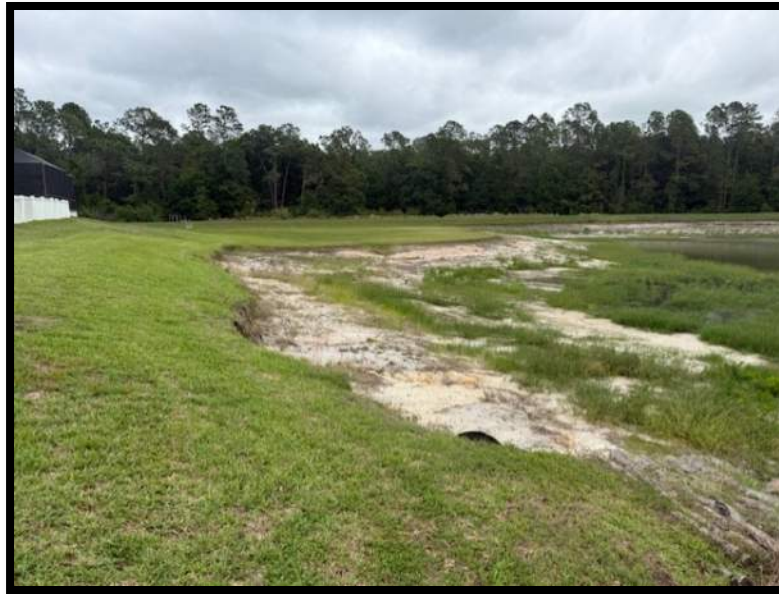
**Photo 145-05**

- Water levels were more than 10ft below the design SHW (see Photo 145-05 on next page for visual reference).

The water level in Pond 14-5 was severely low at the time of the site visit. Review of aerial imagery indicates that, except for periods immediately during and after extreme storm events, the pond water level does not inundate the littoral shelf. Due to such continuous and persistent low water levels, it is possible that the integrity of the pond bottom has been compromised or breached. Investigation of the pond bottom condition and integrity is beyond the scope of this evaluation. The persistent low water elevations have resulted in large swaths of the pond banks, which were designed to be submerged, to be exposed to erosion from stormwater runoff. The low water levels

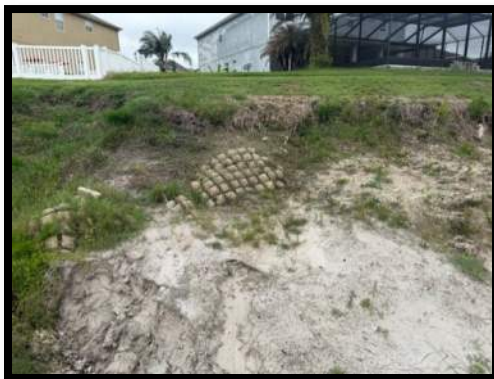
**Photo 145-03**

- Pond banks surrounding culvert (both uphill and downhill) in northwest corner of pond have failed and are severely eroded. Culvert support has been compromised, and culvert is in danger of breaking/failing. Ad hoc repairs (rip rap, concrete rubble, sections of articulated concrete mat) both above and below the culvert have been ineffective. Discharge from culvert has carved a significant channel into the exposed pond bottom, indicating large amounts of material have been deposited in deeper sections of the pond. Refer to Photos 145-03, 145-04, 145-09, 145-10, 145-19, and 145-22 below.

- Bank has sloughed/failed completely adjacent to and upslope of the culvert, with the failed area soon to be endangering homeowner’s fencing and property. The culvert and MES remain intact, but the ME has been undermined, and soil is disappearing from beneath it.

- Unstable and compromised material, along with the debris and apparatus used to enact temporary repairs, must be removed to reach stable/native bank material.

- Clean fill material must then be placed to restore the original pond bank slope, position, and grade per the plans. Material should be placed in 8-12” lifts and compacted. Based on a visual comparison of the amount of material “missing” from the bank and the pond bank as shown on the plans, fill material will need to be imported.

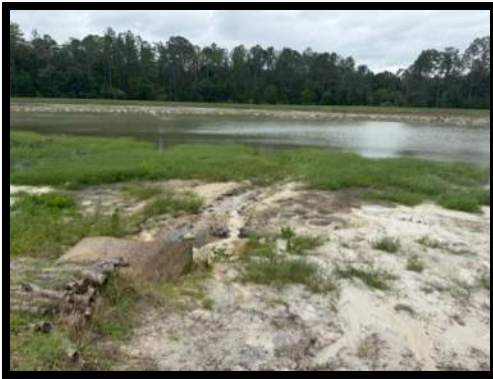
**Photo 145-07**

- Pond banks adjacent to the inflow culvert in the center portion of the northern shoreline are failing. Discharge from the culvert onto bare/exposed soils has resulted in major erosion and material transfer into the pond, leaving a “sump” or hole at the outfall which has progressed beneath the mitered end section (MES) of the culvert. The sump has been filled with concrete rubble, as well as the open space beneath the MES, in an attempt to halt the erosion and prevent the MES from failing/breaking off. Refer to Photos 145-07 and 145-18 on the following page.

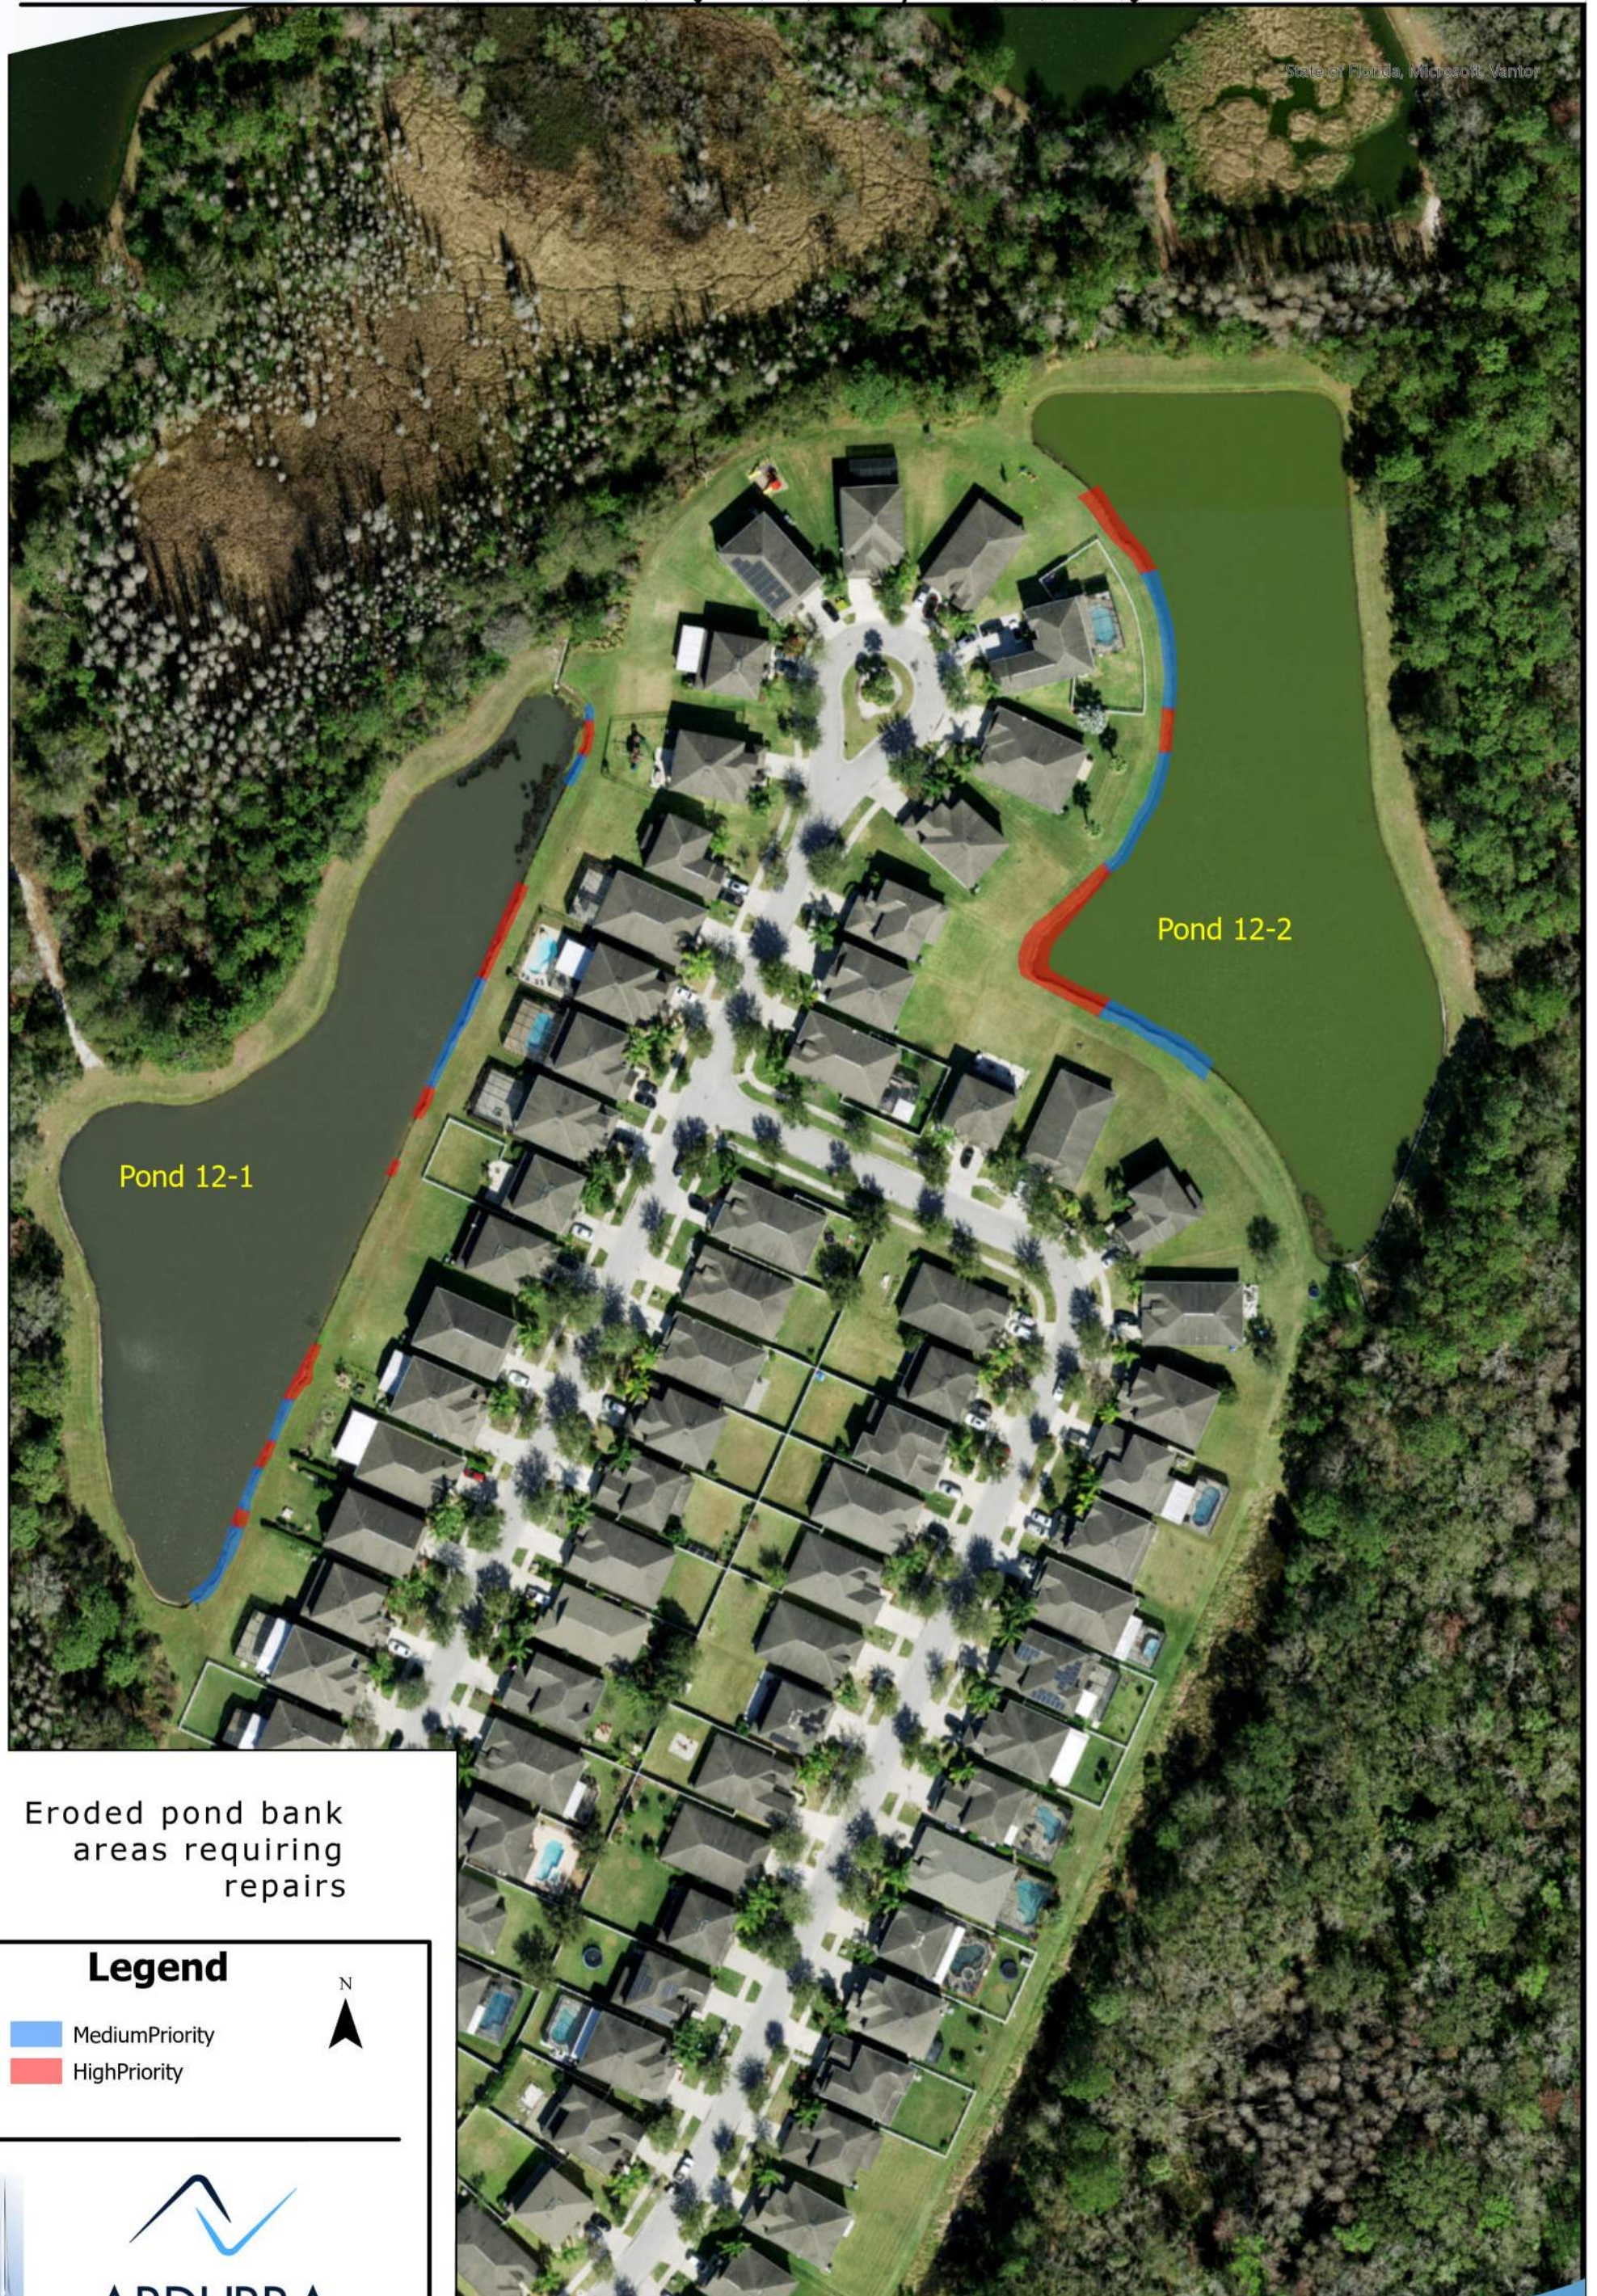
Areas where intervention is needed to address erosion issues have been classified as “High Priority” and “Medium Priority” pursuant to the severity of the issue. If corrective actions are not implemented in these areas, the banks will continue to degrade and eventually fail. These areas have been identified on **Attachment 2** for Pond 12-1 and 12-2.

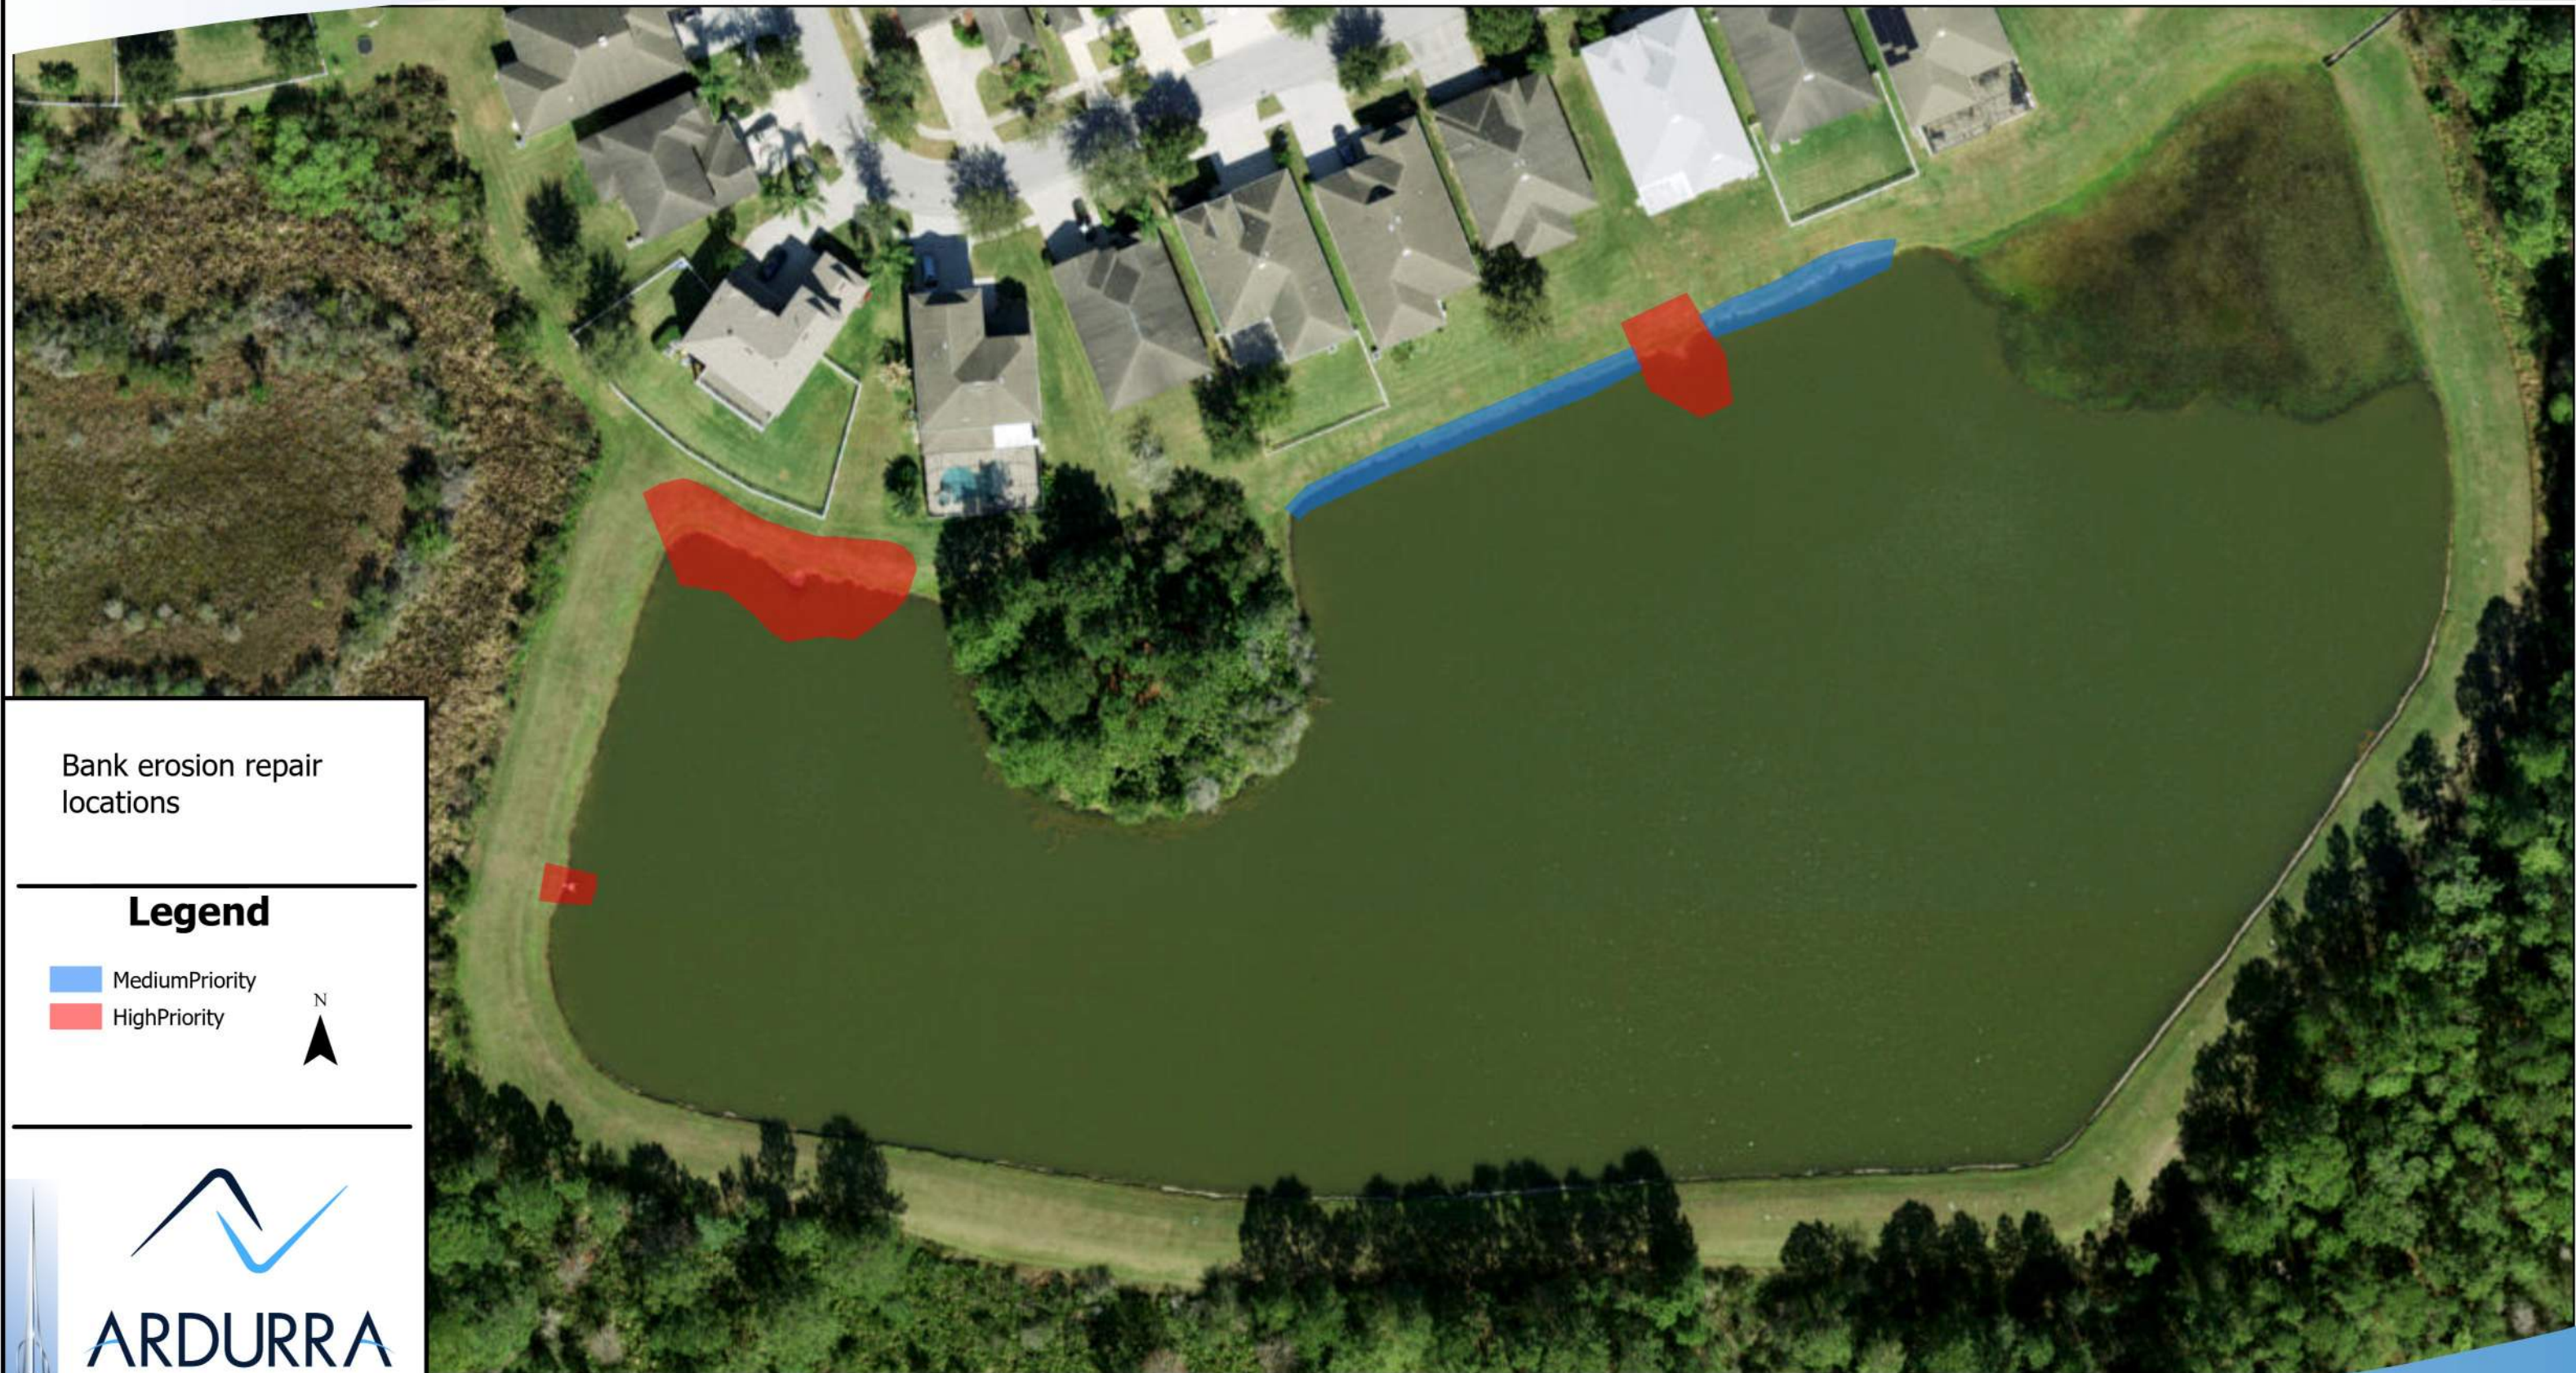
# ATTACHMENT 3 (POND 14-5)

Areas where intervention is needed to address erosion issues have been classified as “High Priority” and “Medium Priority” pursuant to the severity of the issue. If corrective actions are not implemented in these areas, the banks will continue to degrade and eventually fail. These areas have been identified on **Attachment 3** for Pond 14-5.
