***Live Oak No. 2  
Community Development  
District***

**October 15, 2026**

**Agenda Package**

**i. Consideration of Phase 2B Littoral Shelf Evaluation and Planting Recommendations -  
Ponds 12-1, 12-2, 12-3 and 13-1 Proposals**

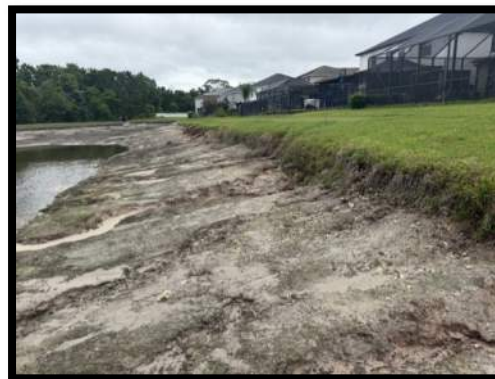
**Photo 121-10**

- Water levels were approximately 7ft below the design SHW (see Photo 121-10 below for visual reference).
- An abrupt vertical drop/lip, ranging in height from 12" to 18" or more, is present around the entire perimeter of the pond (see Photo 121-10 below for visual reference).

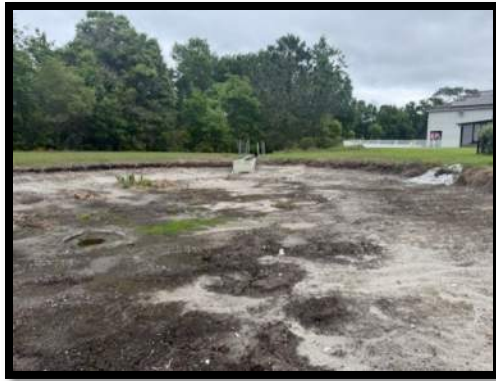
**Photo 121-12**

- Between the lip and water, the exposed pond bank and bottom is bare sandy soil, devoid of any noteworthy vegetation. This is the case in the main body of the pond as well as in the littoral zone (reference Photos 121-12 and 121-19 below).
- The littoral zone area of the pond was completely dry, with no visible evidence of recent inundation. Only small, isolated clusters of vegetation were present (see Photo 121-12 below).

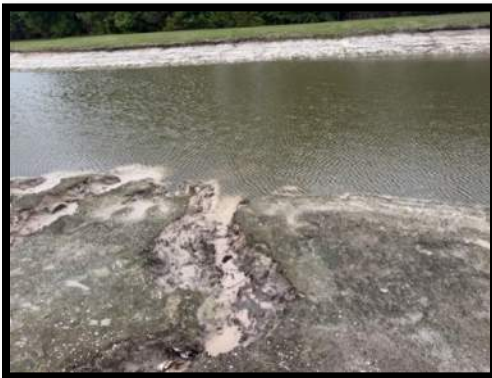
**Photo 121-06**

- Visual evidence of persistent damaging erosion along the eastern edge of the pond (behind homes). Concentrated runoff has carved rills/channels into the exposed pond bottom, indicating water levels have been low for an extended period of time (if at SHW, the water would absorb the energy from the runoff and would not scour/carve the pond bottom). Refer to Photos 121-06, 121-08, 121-26, 121-27, and 121-28 below. All instances of this condition are on the eastern bank of the pond (behind homes).

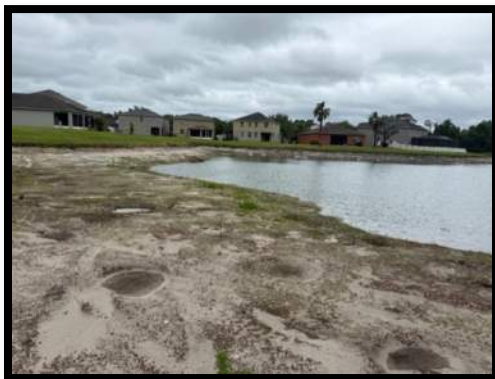
**Photo 122-40**

- Water levels were approximately 6ft below the design SHW (see Photo 122-40 below for visual reference).
- An abrupt vertical drop/lip, ranging in height from 12" to 18" or more, is present around the entire perimeter of the pond (see Photos 122-43 and 122-44 below for visual reference).

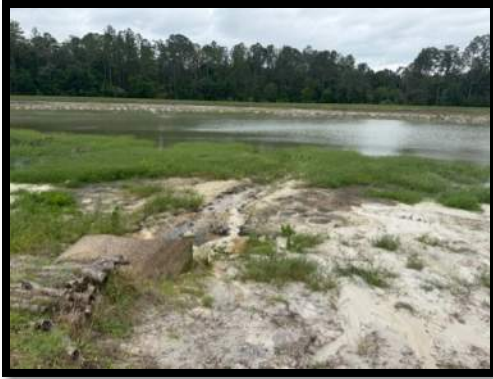
**Photo 145-07**

- Pond banks adjacent to the inflow culvert in the center portion of the northern shoreline are failing. Discharge from the culvert onto bare/exposed soils has resulted in major erosion and material transfer into the pond, leaving a “sump” or hole at the outfall which has progressed beneath the mitered end section (MES) of the culvert. The sump has been filled with concrete rubble, as well as the open space beneath the MES, in an attempt to halt the erosion and prevent the MES from failing/breaking off. Refer to Photos 145-07 and 145-18 on the following page.

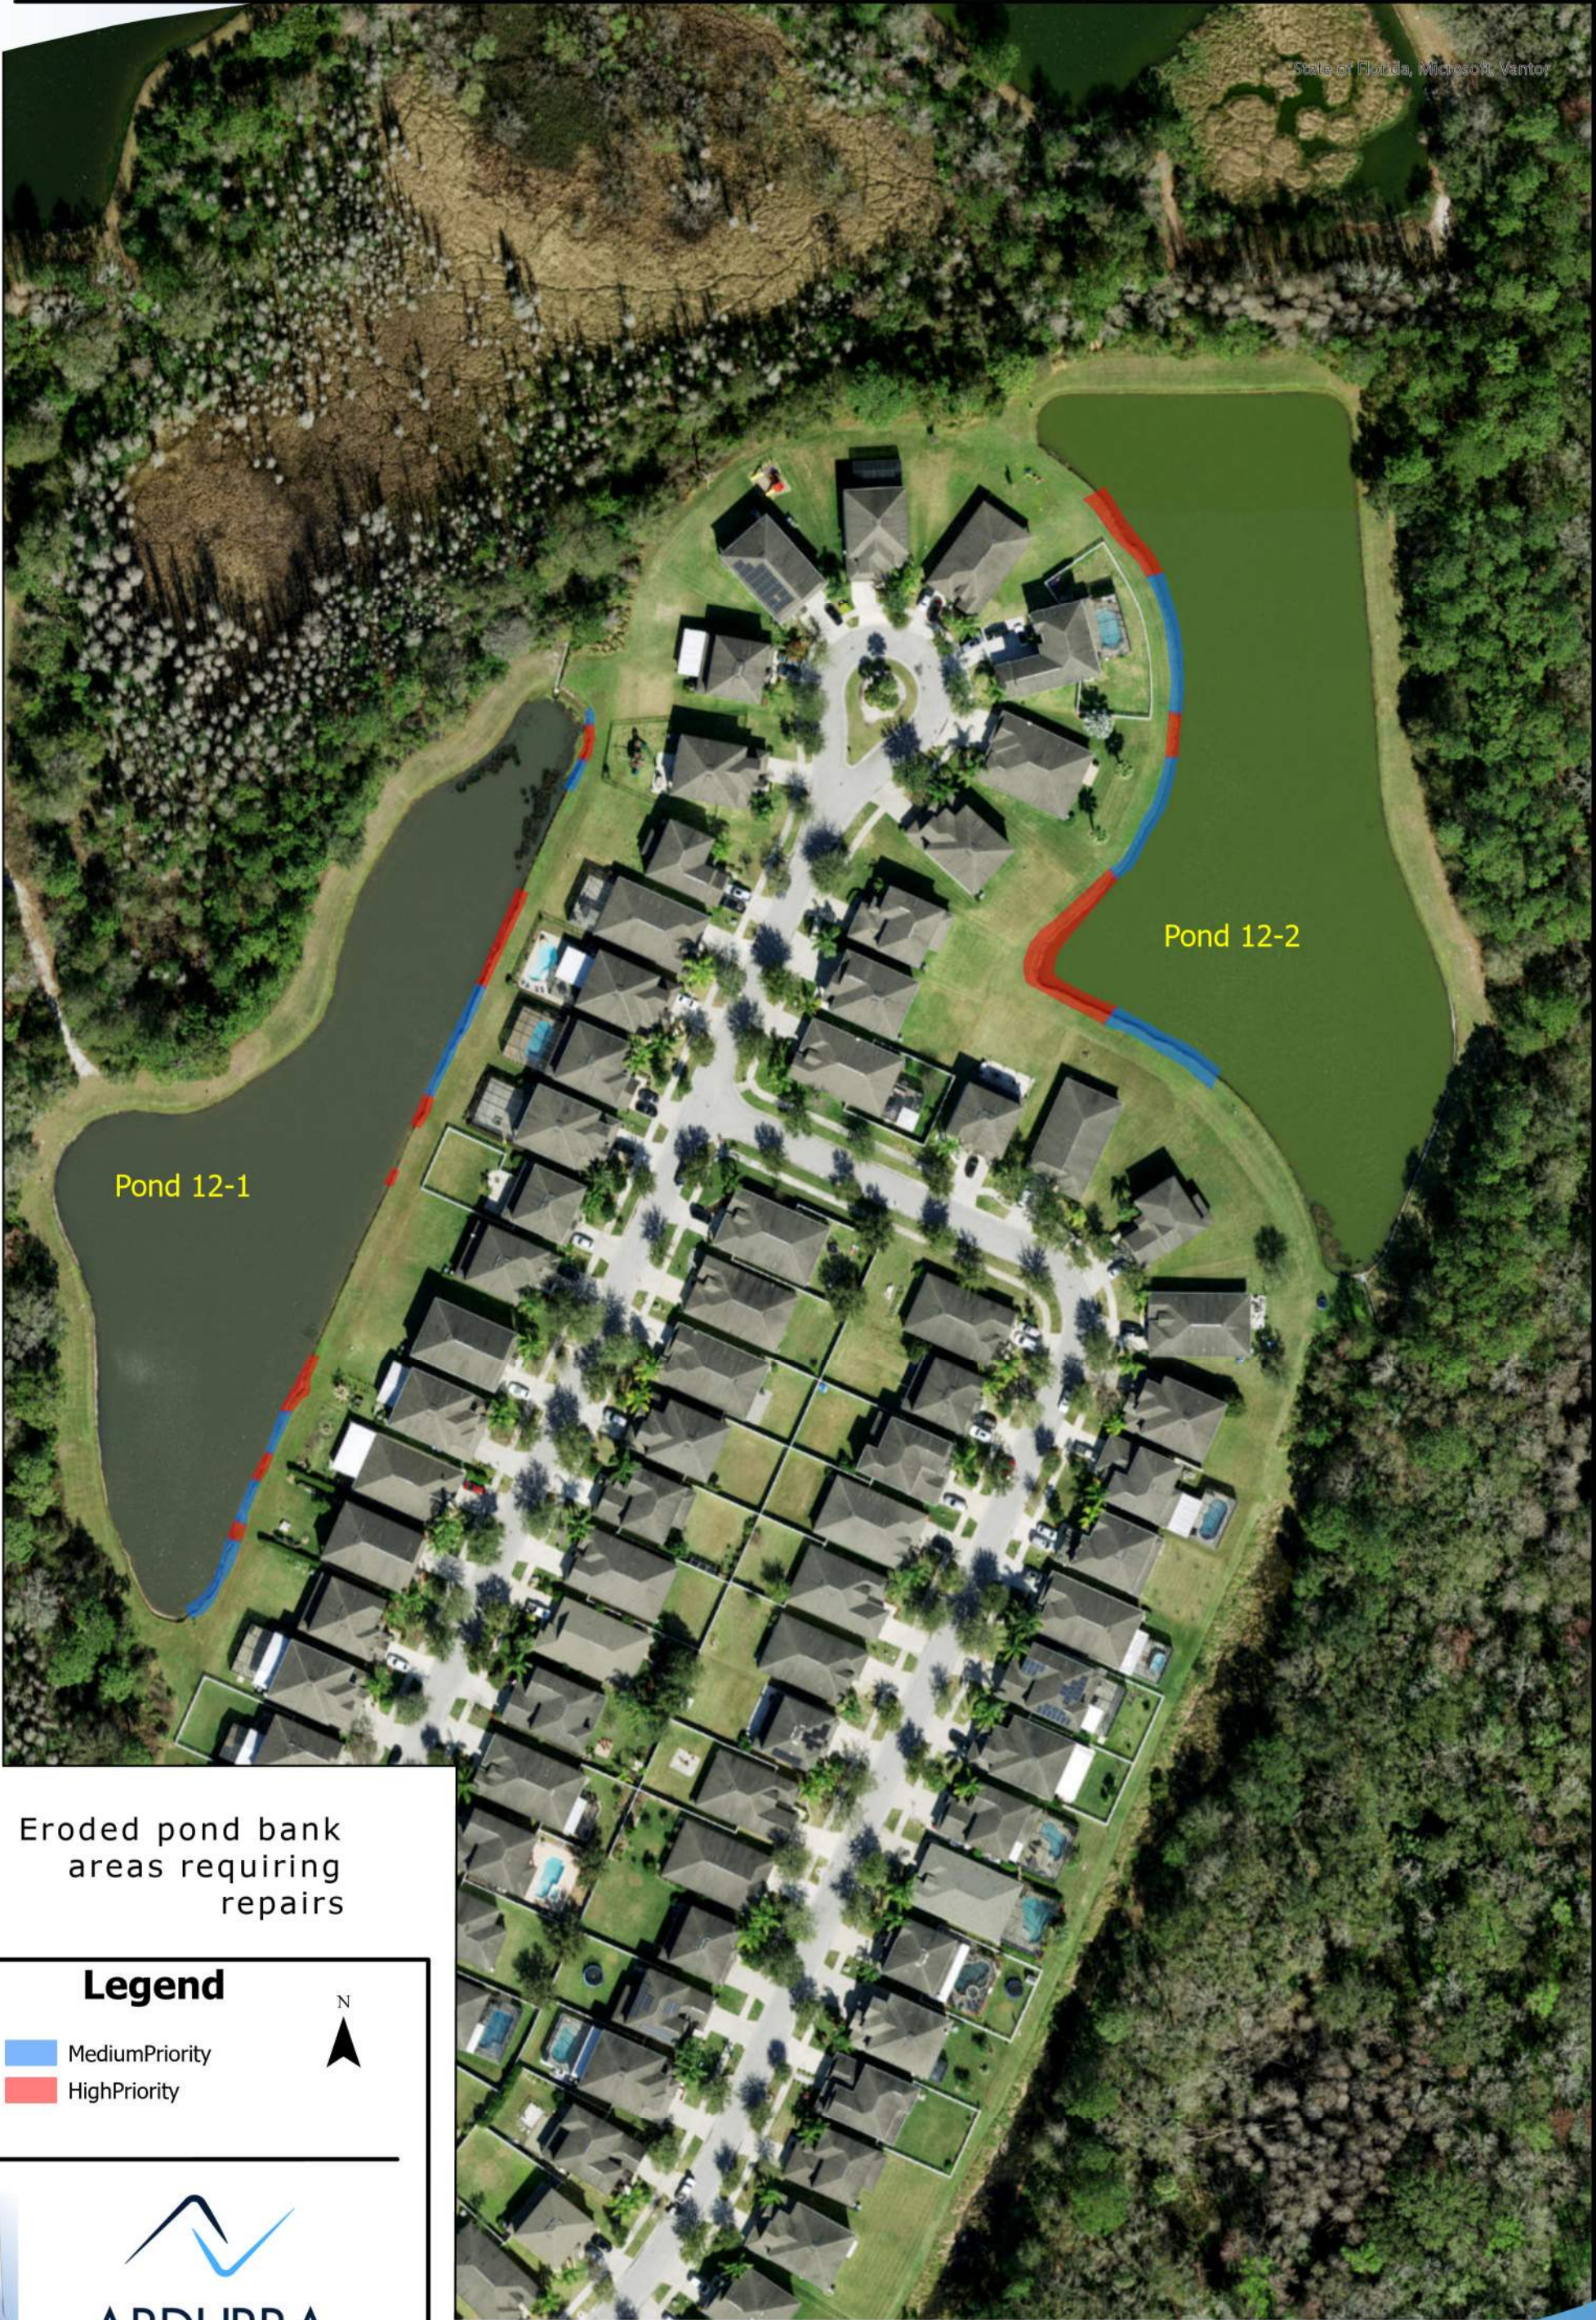
Eroded pond bank areas requiring repairs

Areas where intervention is needed to address erosion issues have been classified as “High Priority” and “Medium Priority” pursuant to the severity of the issue. If corrective actions are not implemented in these areas, the banks will continue to degrade and eventually fail. These areas have been identified on **Attachment 2** for Pond 12-1 and 12-2.
