***Live Oak No. 2  
Community Development  
District***

# Live Oak II Community Development District

**i. Consideration of Phase 2B Littoral Shelf Evaluation and Planting Recommendations -  
Ponds 12-1, 12-2, 12-3 and 13-1 Proposals**

Ardurra visited the site on Tuesday April 7, 2026, and evaluated Pond 12-1, Pond 12-2, and Pond 14-5 relative to conditions at the time of the visit, focusing on the noted bank erosion issues.

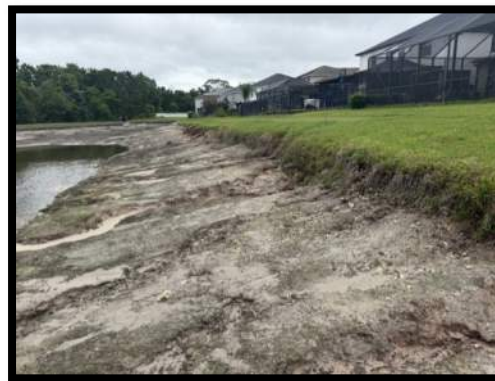
**Photo 121-10**

- Water levels were approximately 7ft below the design SHW (see Photo 121-10 below for visual reference).
- An abrupt vertical drop/lip, ranging in height from 12" to 18" or more, is present around the entire perimeter of the pond (see Photo 121-10 below for visual reference).

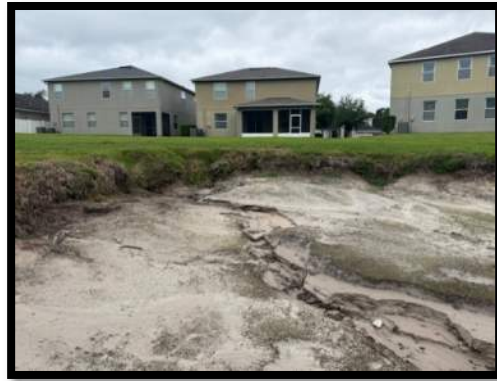
**Photo 122-57**

- Visual evidence of persistent damaging erosion along the western edge of the pond (behind homes). Concentrated runoff has carved rills/channels into the exposed pond bottom, indicating water levels have been low for an extended period of time (if at SHW, the water would absorb the energy from the runoff and would not scour/carve the pond bottom). Refer to Photos 122-14, 122-16, 122-17, 122-19, and 122-35 below. All instances of this condition are on the western bank of the pond (behind homes). The “corner” area on the western bank is in danger of collapse (Photo 122-57 below).

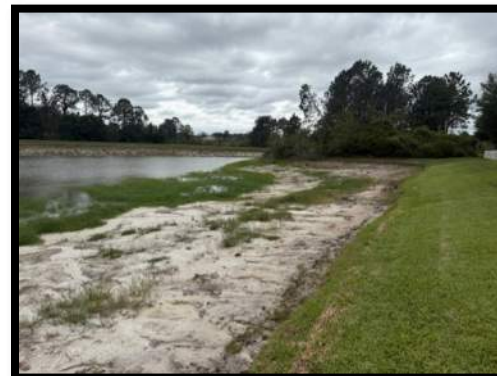
**Photo 145-17**

- An abrupt vertical drop/lip, ranging in height from 12" to 18" or more (in some areas approaching 2ft), is present around the entire perimeter of the pond (see Photos 145-01, 145-05, 145-12, and 145-17 below for visual reference). Although there are areas where runoff is eroding the "lip," there are no areas of severe erosion on the northern (behind homes) shore of the pond – the exceptions being in the areas around the two inflow culverts.

- Bank material should be removed to a horizontal distance from the lip equal to four times the drop height at that location to a depth equal to the drop height, or until all damaged/destabilized material has been removed – whichever distance is greater. For example, if the drop height at the lip is 1ft, the bank face should be excavated 1ft vertically from surface to a distance of 4ft beyond the lip/face. The horizontal distance from the lip face to the extent of the landward excavation shall be designated "X" for this discussion.
