***Live Oak No. 2  
Community Development  
District***

**September 17, 2026**

**Agenda Package**

**i. Consideration of Phase 2B Littoral Shelf Evaluation and Planting Recommendation Ponds 12-1, 12-2, 12-3 and 13-1**

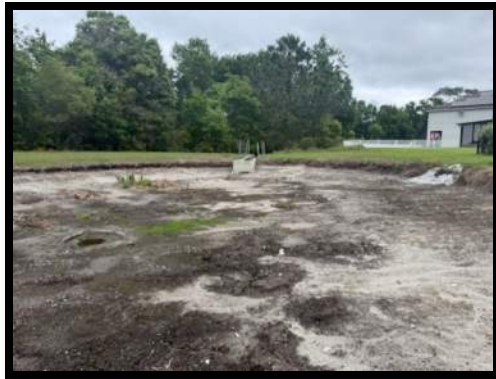
**Photo 121-12**

- Between the lip and water, the exposed pond bank and bottom is bare sandy soil, devoid of any noteworthy vegetation. This is the case in the main body of the pond as well as in the littoral zone (reference Photos 121-12 and 121-19 below).
- The littoral zone area of the pond was completely dry, with no visible evidence of recent inundation. Only small, isolated clusters of vegetation were present (see Photo 121-12 below).

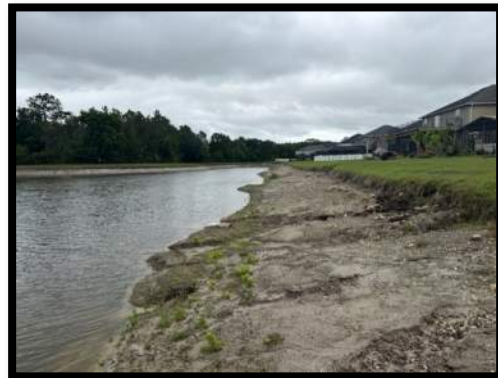
**Photo 121-26**

- Visual evidence of persistent damaging erosion along the eastern edge of the pond (behind homes). Concentrated runoff has carved rills/channels into the exposed pond bottom, indicating water levels have been low for an extended period of time (if at SHW, the water would absorb the energy from the runoff and would not scour/carve the pond bottom). Refer to Photos 121-06, 121-08, 121-26, 121-27, and 121-28 below. All instances of this condition are on the eastern bank of the pond (behind homes).

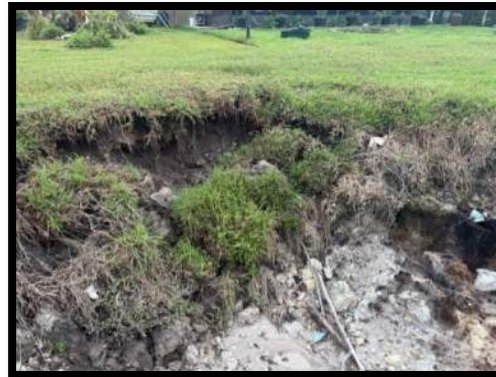
**Photo 121-14**

- Multiple locations of severe erosion and bank failure/sloughing on eastern bank. Home owners have implemented temporary repair measures (gravel, rock, sod blankets, etc.) in several locations in an attempt to stabilize the bank. These locations appear to align with areas between the homes, where runoff may be concentrated by lot grading before spilling over the lip into the pond. See Photos 121-01, 121-11, 121-14, 121-22, 121-23, and 121-25 below for a visual reference.

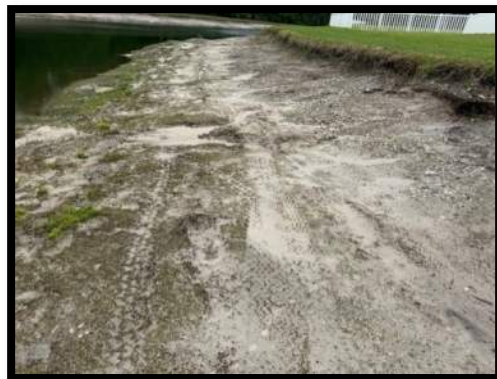
**Photo 122-14**

- Visual evidence of persistent damaging erosion along the western edge of the pond (behind homes). Concentrated runoff has carved rills/channels into the exposed pond bottom, indicating water levels have been low for an extended period of time (if at SHW, the water would absorb the energy from the runoff and would not scour/carve the pond bottom). Refer to Photos 122-14, 122-16, 122-17, 122-19, and 122-35 below. All instances of this condition are on the western bank of the pond (behind homes). The “corner” area on the western bank is in danger of collapse (Photo 122-57 below).

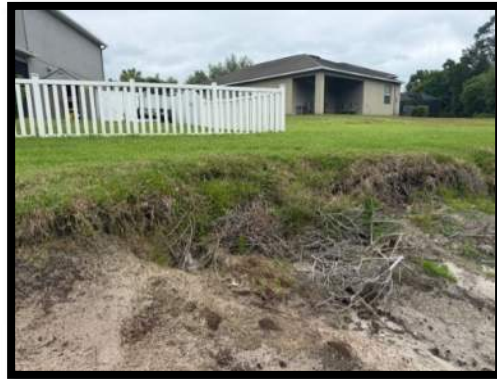
**Photo 122-07**

- Multiple locations of severe erosion and bank failure/sloughing on western bank. These locations appear to align with areas between the homes, where runoff may be concentrated by lot grading before spilling over the lip into the pond. See Photos 121-01, 121-11, 121-14, 121-22, 121-23, and 121-25 below for a visual reference.

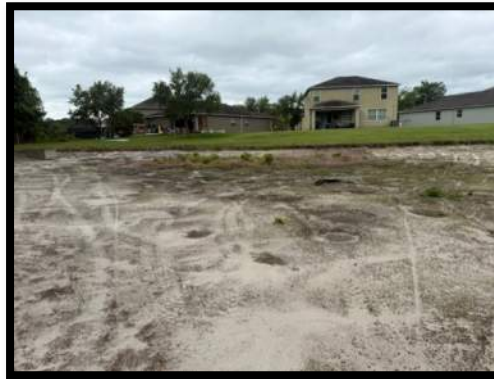
**Photo 122-20**

- The littoral zone area of the pond was completely dry, with no visible evidence of recent inundation. Only small, isolated clusters of vegetation were present (see Photo 122-20 below).

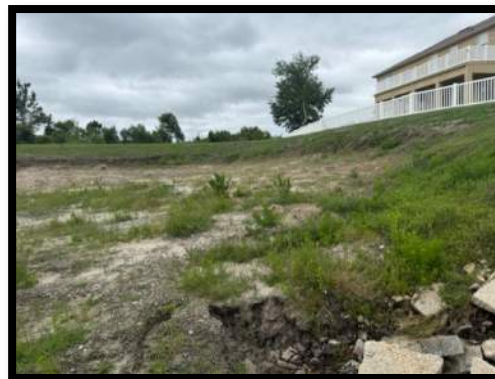
**Photo 145-04**

- Pond banks surrounding culvert (both uphill and downhill) in northwest corner of pond have failed and are severely eroded. Culvert support has been compromised, and culvert is in danger of breaking/failing. Ad hoc repairs (rip rap, concrete rubble, sections of articulated concrete mat) both above and below the culvert have been ineffective. Discharge from culvert has carved a significant channel into the exposed pond bottom, indicating large amounts of material have been deposited in deeper sections of the pond. Refer to Photos 145-03, 145-04, 145-09, 145-10, 145-19, and 145-22 below.

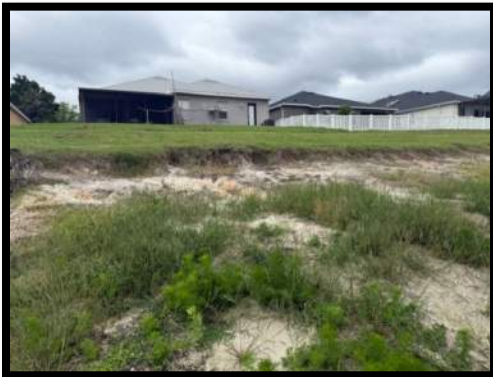
**Photo 145-01**

- An abrupt vertical drop/lip, ranging in height from 12" to 18" or more (in some areas approaching 2ft), is present around the entire perimeter of the pond (see Photos 145-01, 145-05, 145-12, and 145-17 below for visual reference). Although there are areas where runoff is eroding the "lip," there are no areas of severe erosion on the northern (behind homes) shore of the pond – the exceptions being in the areas around the two inflow culverts.

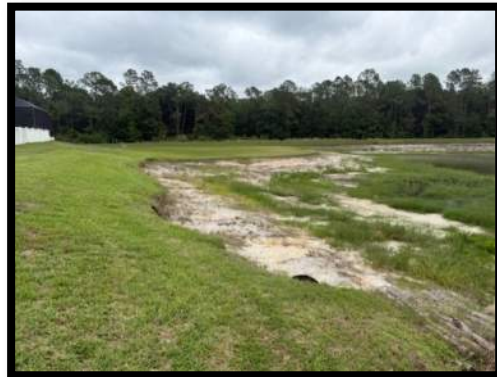
**Photo 145-05**

- Water levels were more than 10ft below the design SHW (see Photo 145-05 on next page for visual reference).

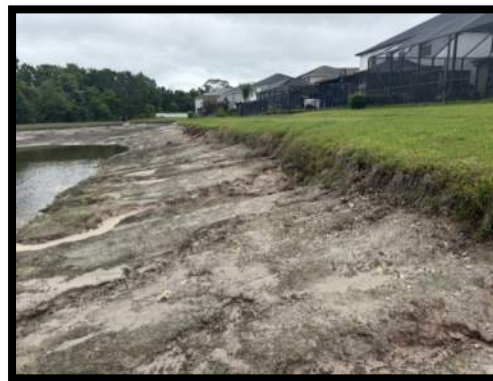
**Photo 121-10**

- Water levels were approximately 7ft below the design SHW (see Photo 121-10 below for visual reference).
- An abrupt vertical drop/lip, ranging in height from 12" to 18" or more, is present around the entire perimeter of the pond (see Photo 121-10 below for visual reference).

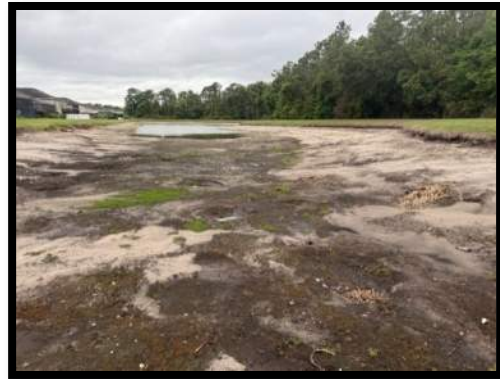
**Photo 121-19**

- Between the lip and water, the exposed pond bank and bottom is bare sandy soil, devoid of any noteworthy vegetation. This is the case in the main body of the pond as well as in the littoral zone (reference Photos 121-12 and 121-19 below).
- The littoral zone area of the pond was completely dry, with no visible evidence of recent inundation. Only small, isolated clusters of vegetation were present (see Photo 121-12 below).

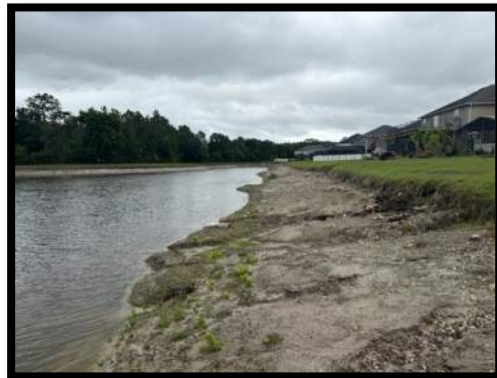
**Photo 121-08**

- Visual evidence of persistent damaging erosion along the eastern edge of the pond (behind homes). Concentrated runoff has carved rills/channels into the exposed pond bottom, indicating water levels have been low for an extended period of time (if at SHW, the water would absorb the energy from the runoff and would not scour/carve the pond bottom). Refer to Photos 121-06, 121-08, 121-26, 121-27, and 121-28 below. All instances of this condition are on the eastern bank of the pond (behind homes).

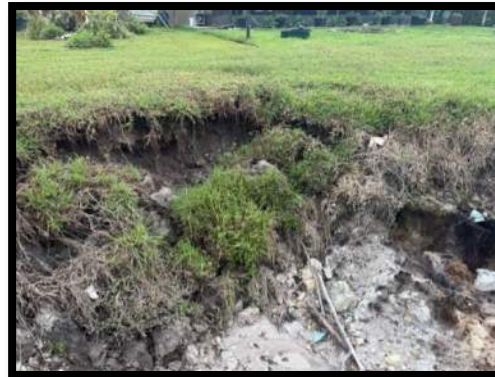
**Photo 121-11**

- Multiple locations of severe erosion and bank failure/sloughing on eastern bank. Home owners have implemented temporary repair measures (gravel, rock, sod blankets, etc.) in several locations in an attempt to stabilize the bank. These locations appear to align with areas between the homes, where runoff may be concentrated by lot grading before spilling over the lip into the pond. See Photos 121-01, 121-11, 121-14, 121-22, 121-23, and 121-25 below for a visual reference.

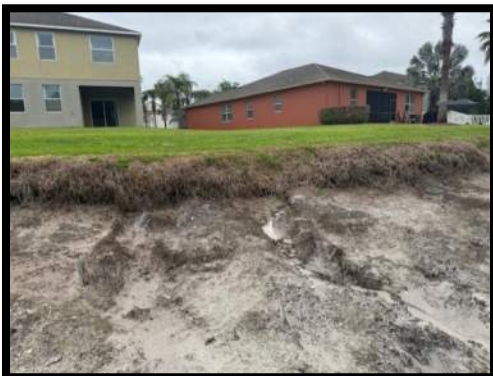
**Photo 122-37**

- Multiple locations of severe erosion and bank failure/sloughing on western bank. These locations appear to align with areas between the homes, where runoff may be concentrated by lot grading before spilling over the lip into the pond. See Photos 121-01, 121-11, 121-14, 121-22, 121-23, and 121-25 below for a visual reference.

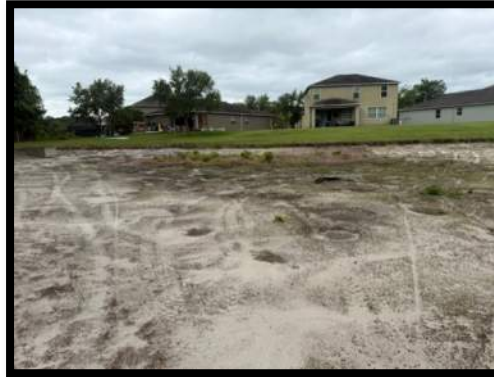
**Photo 122-20**

- The littoral zone area of the pond was completely dry, with no visible evidence of recent inundation. Only small, isolated clusters of vegetation were present (see Photo 122-20 below).

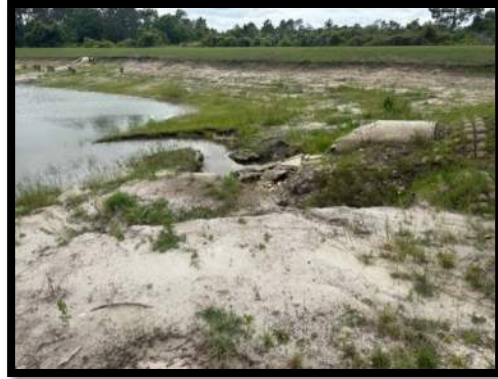
**Photo 145-22**

- Pond banks surrounding culvert (both uphill and downhill) in northwest corner of pond have failed and are severely eroded. Culvert support has been compromised, and culvert is in danger of breaking/failing. Ad hoc repairs (rip rap, concrete rubble, sections of articulated concrete mat) both above and below the culvert have been ineffective. Discharge from culvert has carved a significant channel into the exposed pond bottom, indicating large amounts of material have been deposited in deeper sections of the pond. Refer to Photos 145-03, 145-04, 145-09, 145-10, 145-19, and 145-22 below.

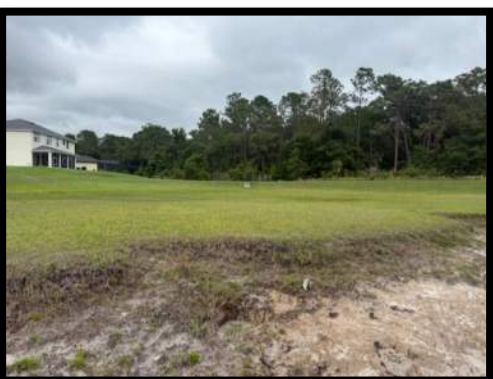
**Photo 145-12**

- An abrupt vertical drop/lip, ranging in height from 12" to 18" or more (in some areas approaching 2ft), is present around the entire perimeter of the pond (see Photos 145-01, 145-05, 145-12, and 145-17 below for visual reference). Although there are areas where runoff is eroding the "lip," there are no areas of severe erosion on the northern (behind homes) shore of the pond – the exceptions being in the areas around the two inflow culverts.

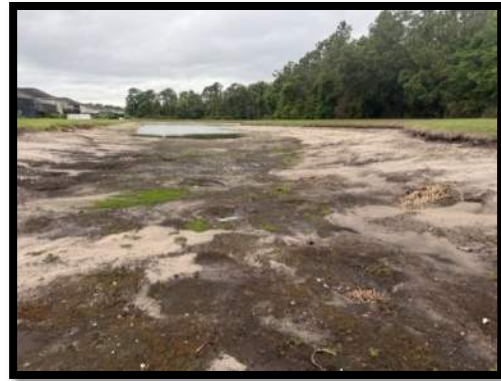
**Photo 121-19**

- Between the lip and water, the exposed pond bank and bottom is bare sandy soil, devoid of any noteworthy vegetation. This is the case in the main body of the pond as well as in the littoral zone (reference Photos 121-12 and 121-19 below).
- The littoral zone area of the pond was completely dry, with no visible evidence of recent inundation. Only small, isolated clusters of vegetation were present (see Photo 121-12 below).

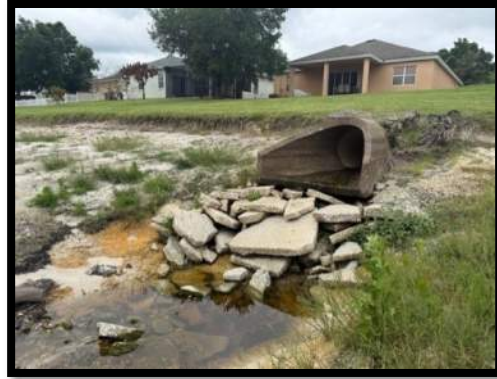
**Photo 145-18**

- Pond banks adjacent to the inflow culvert in the center portion of the northern shoreline are failing. Discharge from the culvert onto bare/exposed soils has resulted in major erosion and material transfer into the pond, leaving a “sump” or hole at the outfall which has progressed beneath the mitered end section (MES) of the culvert. The sump has been filled with concrete rubble, as well as the open space beneath the MES, in an attempt to halt the erosion and prevent the MES from failing/breaking off. Refer to Photos 145-07 and 145-18 on the following page.

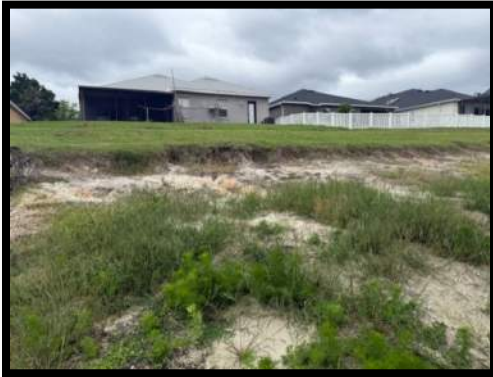
**Photo 145-01**

- An abrupt vertical drop/lip, ranging in height from 12" to 18" or more (in some areas approaching 2ft), is present around the entire perimeter of the pond (see Photos 145-01, 145-05, 145-12, and 145-17 below for visual reference). Although there are areas where runoff is eroding the "lip," there are no areas of severe erosion on the northern (behind homes) shore of the pond – the exceptions being in the areas around the two inflow culverts.

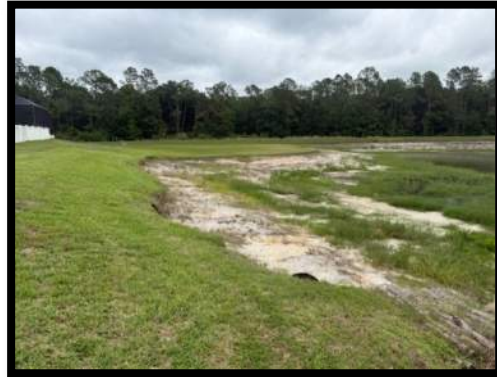
**Photo 145-05**

- Water levels were more than 10ft below the design SHW (see Photo 145-05 on next page for visual reference).
