***Live Oak No. 2  
Community Development  
District***

**October 15, 2026**

**Agenda Package**

**i. Consideration of Phase 2B Littoral Shelf Evaluation and Planting Recommendations -  
Ponds 12-1, 12-2, 12-3 and 13-1 Proposals**

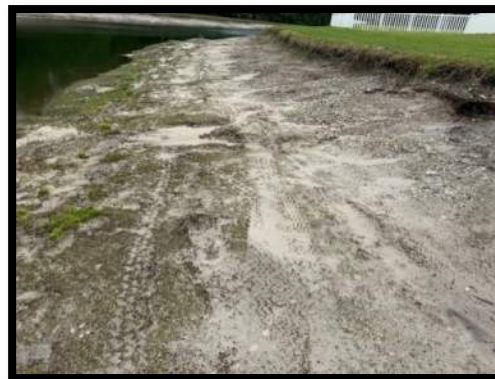
**Photo 122-43**

- Water levels were approximately 6ft below the design SHW (see Photo 122-40 below for visual reference).
- An abrupt vertical drop/lip, ranging in height from 12" to 18" or more, is present around the entire perimeter of the pond (see Photos 122-43 and 122-44 below for visual reference).

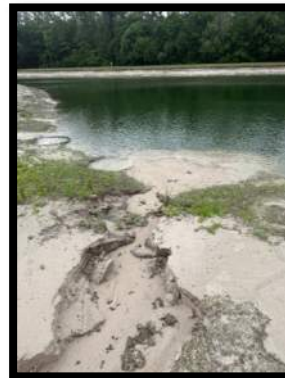
**Photo 122-16**

- Visual evidence of persistent damaging erosion along the western edge of the pond (behind homes). Concentrated runoff has carved rills/channels into the exposed pond bottom, indicating water levels have been low for an extended period of time (if at SHW, the water would absorb the energy from the runoff and would not scour/carve the pond bottom). Refer to Photos 122-14, 122-16, 122-17, 122-19, and 122-35 below. All instances of this condition are on the western bank of the pond (behind homes). The “corner” area on the western bank is in danger of collapse (Photo 122-57 below).

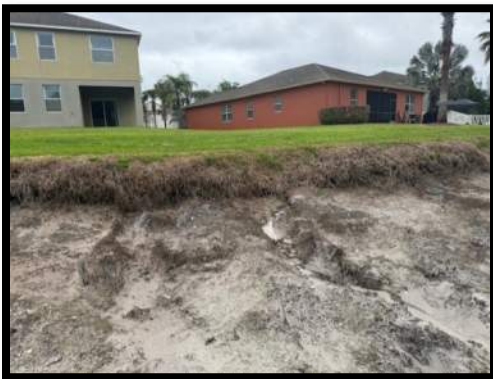
**Photo 122-37**

- Multiple locations of severe erosion and bank failure/sloughing on western bank. These locations appear to align with areas between the homes, where runoff may be concentrated by lot grading before spilling over the lip into the pond. See Photos 121-01, 121-11, 121-14, 121-22, 121-23, and 121-25 below for a visual reference.

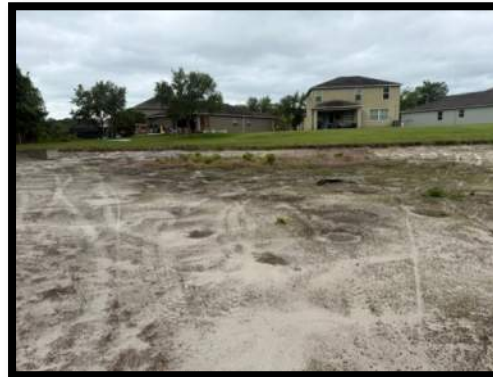
**Photo 122-20**

- The littoral zone area of the pond was completely dry, with no visible evidence of recent inundation. Only small, isolated clusters of vegetation were present (see Photo 122-20 below).

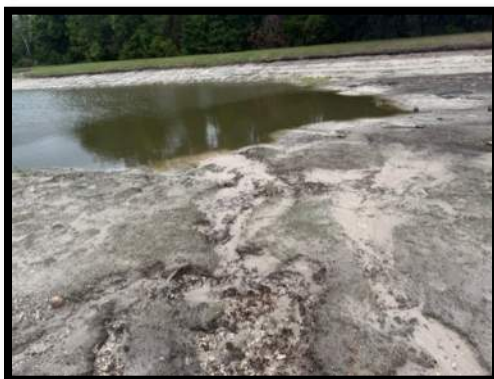
**Photo 121-26**

- Visual evidence of persistent damaging erosion along the eastern edge of the pond (behind homes). Concentrated runoff has carved rills/channels into the exposed pond bottom, indicating water levels have been low for an extended period of time (if at SHW, the water would absorb the energy from the runoff and would not scour/carve the pond bottom). Refer to Photos 121-06, 121-08, 121-26, 121-27, and 121-28 below. All instances of this condition are on the eastern bank of the pond (behind homes).

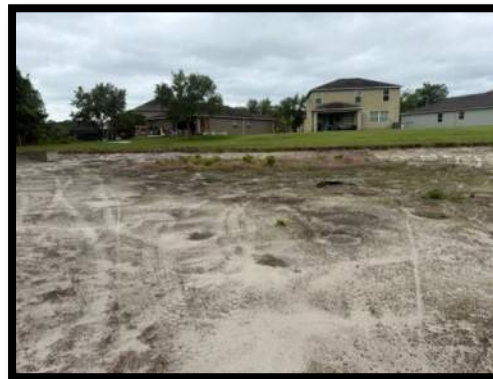
**Photo 122-20**

- The littoral zone area of the pond was completely dry, with no visible evidence of recent inundation. Only small, isolated clusters of vegetation were present (see Photo 122-20 below).
