***Live Oak No. 2  
Community Development  
District***

# Live Oak II Community Development District

**i. Consideration of Phase 2B Littoral Shelf Evaluation and Planting Recommendations -  
Ponds 12-1, 12-2, 12-3 and 13-1 Proposals**

Ardurra visited the site on Tuesday April 7, 2026, and evaluated Pond 12-1, Pond 12-2, and Pond 14-5 relative to conditions at the time of the visit, focusing on the noted bank erosion issues.

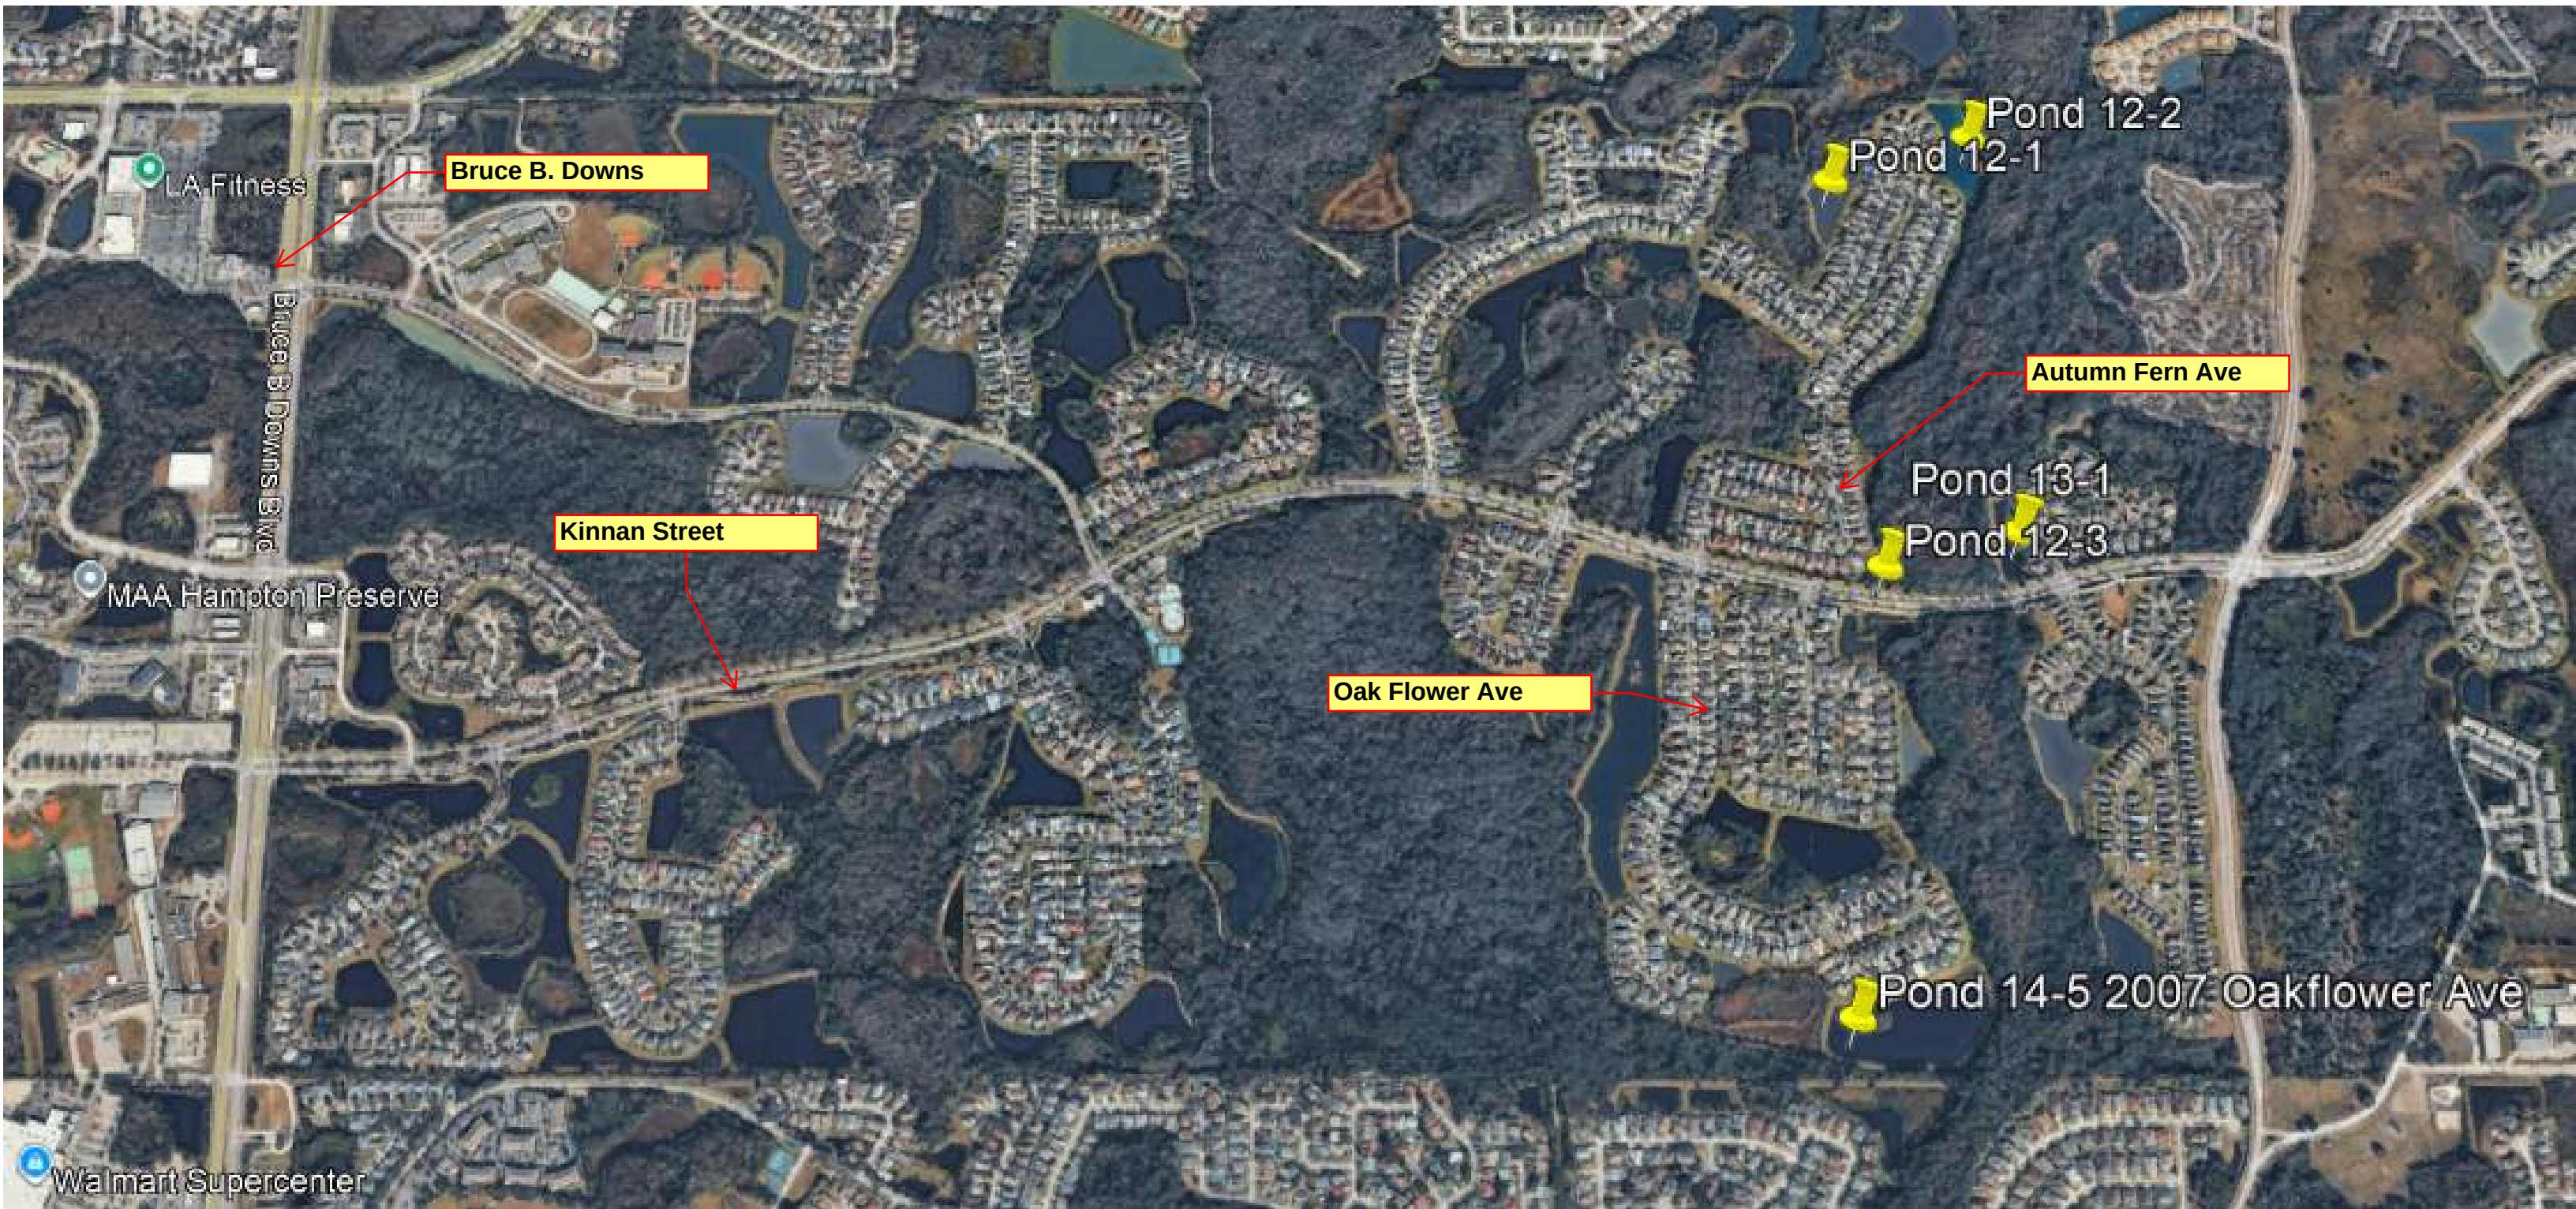
## Attachment 1: Live Oak Preserve Aerial

Eroded pond bank areas requiring repairs

After the above actions have been implemented in the High and Medium Priority areas, the rills and small channels that remain (beyond the newly created slopes that extend “into” the pond) should be smoothed by spreading the adjacent soil to fill (clean fill not required). Future runoff from the repaired upslope areas, even if water levels remain such that the areas remain exposed, will be diffused and not concentrated, and should not propagate similar rills or channels. Should small quantities of additional material be required to complete the slope construction it can be scraped (do not create channels or holes) from the exposed pond bank/bottom in an area away from the repairs. If excess material remains after slope construction, it can spread on the exposed pond bank/bottom to fill any rills or small channels that have formed.

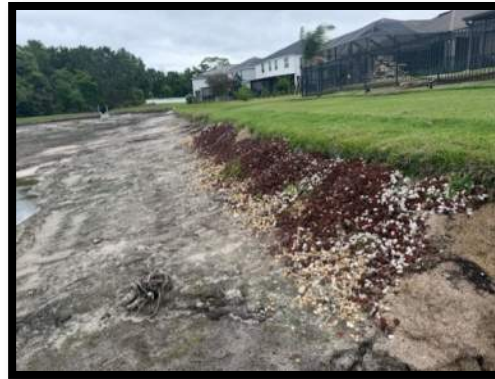
**Photo 121-25**

- Multiple locations of severe erosion and bank failure/sloughing on eastern bank. Home owners have implemented temporary repair measures (gravel, rock, sod blankets, etc.) in several locations in an attempt to stabilize the bank. These locations appear to align with areas between the homes, where runoff may be concentrated by lot grading before spilling over the lip into the pond. See Photos 121-01, 121-11, 121-14, 121-22, 121-23, and 121-25 below for a visual reference.

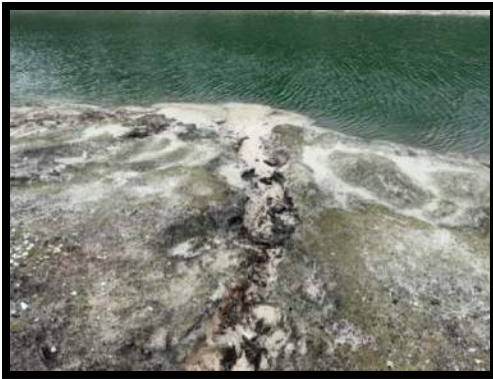
**Photo 122-35**

- Visual evidence of persistent damaging erosion along the western edge of the pond (behind homes). Concentrated runoff has carved rills/channels into the exposed pond bottom, indicating water levels have been low for an extended period of time (if at SHW, the water would absorb the energy from the runoff and would not scour/carve the pond bottom). Refer to Photos 122-14, 122-16, 122-17, 122-19, and 122-35 below. All instances of this condition are on the western bank of the pond (behind homes). The “corner” area on the western bank is in danger of collapse (Photo 122-57 below).

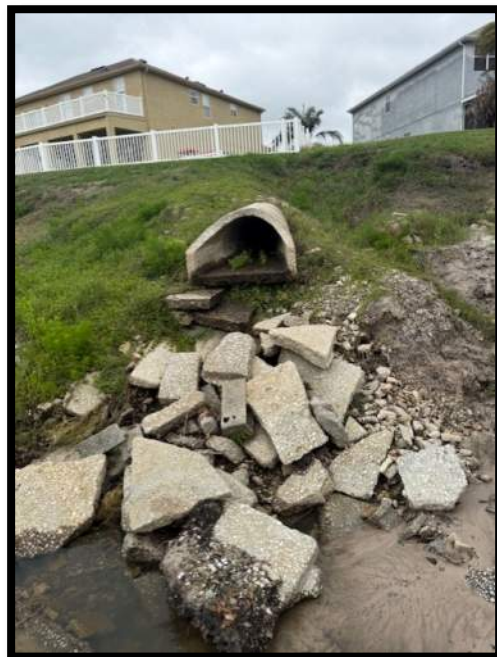
**Photo 145-19**

- Pond banks adjacent to the inflow culvert in the center portion of the northern shoreline are failing. Discharge from the culvert onto bare/exposed soils has resulted in major erosion and material transfer into the pond, leaving a “sump” or hole at the outfall which has progressed beneath the mitered end section (MES) of the culvert. The sump has been filled with concrete rubble, as well as the open space beneath the MES, in an attempt to halt the erosion and prevent the MES from failing/breaking off. Refer to Photos 145-07 and 145-18 on the following page.

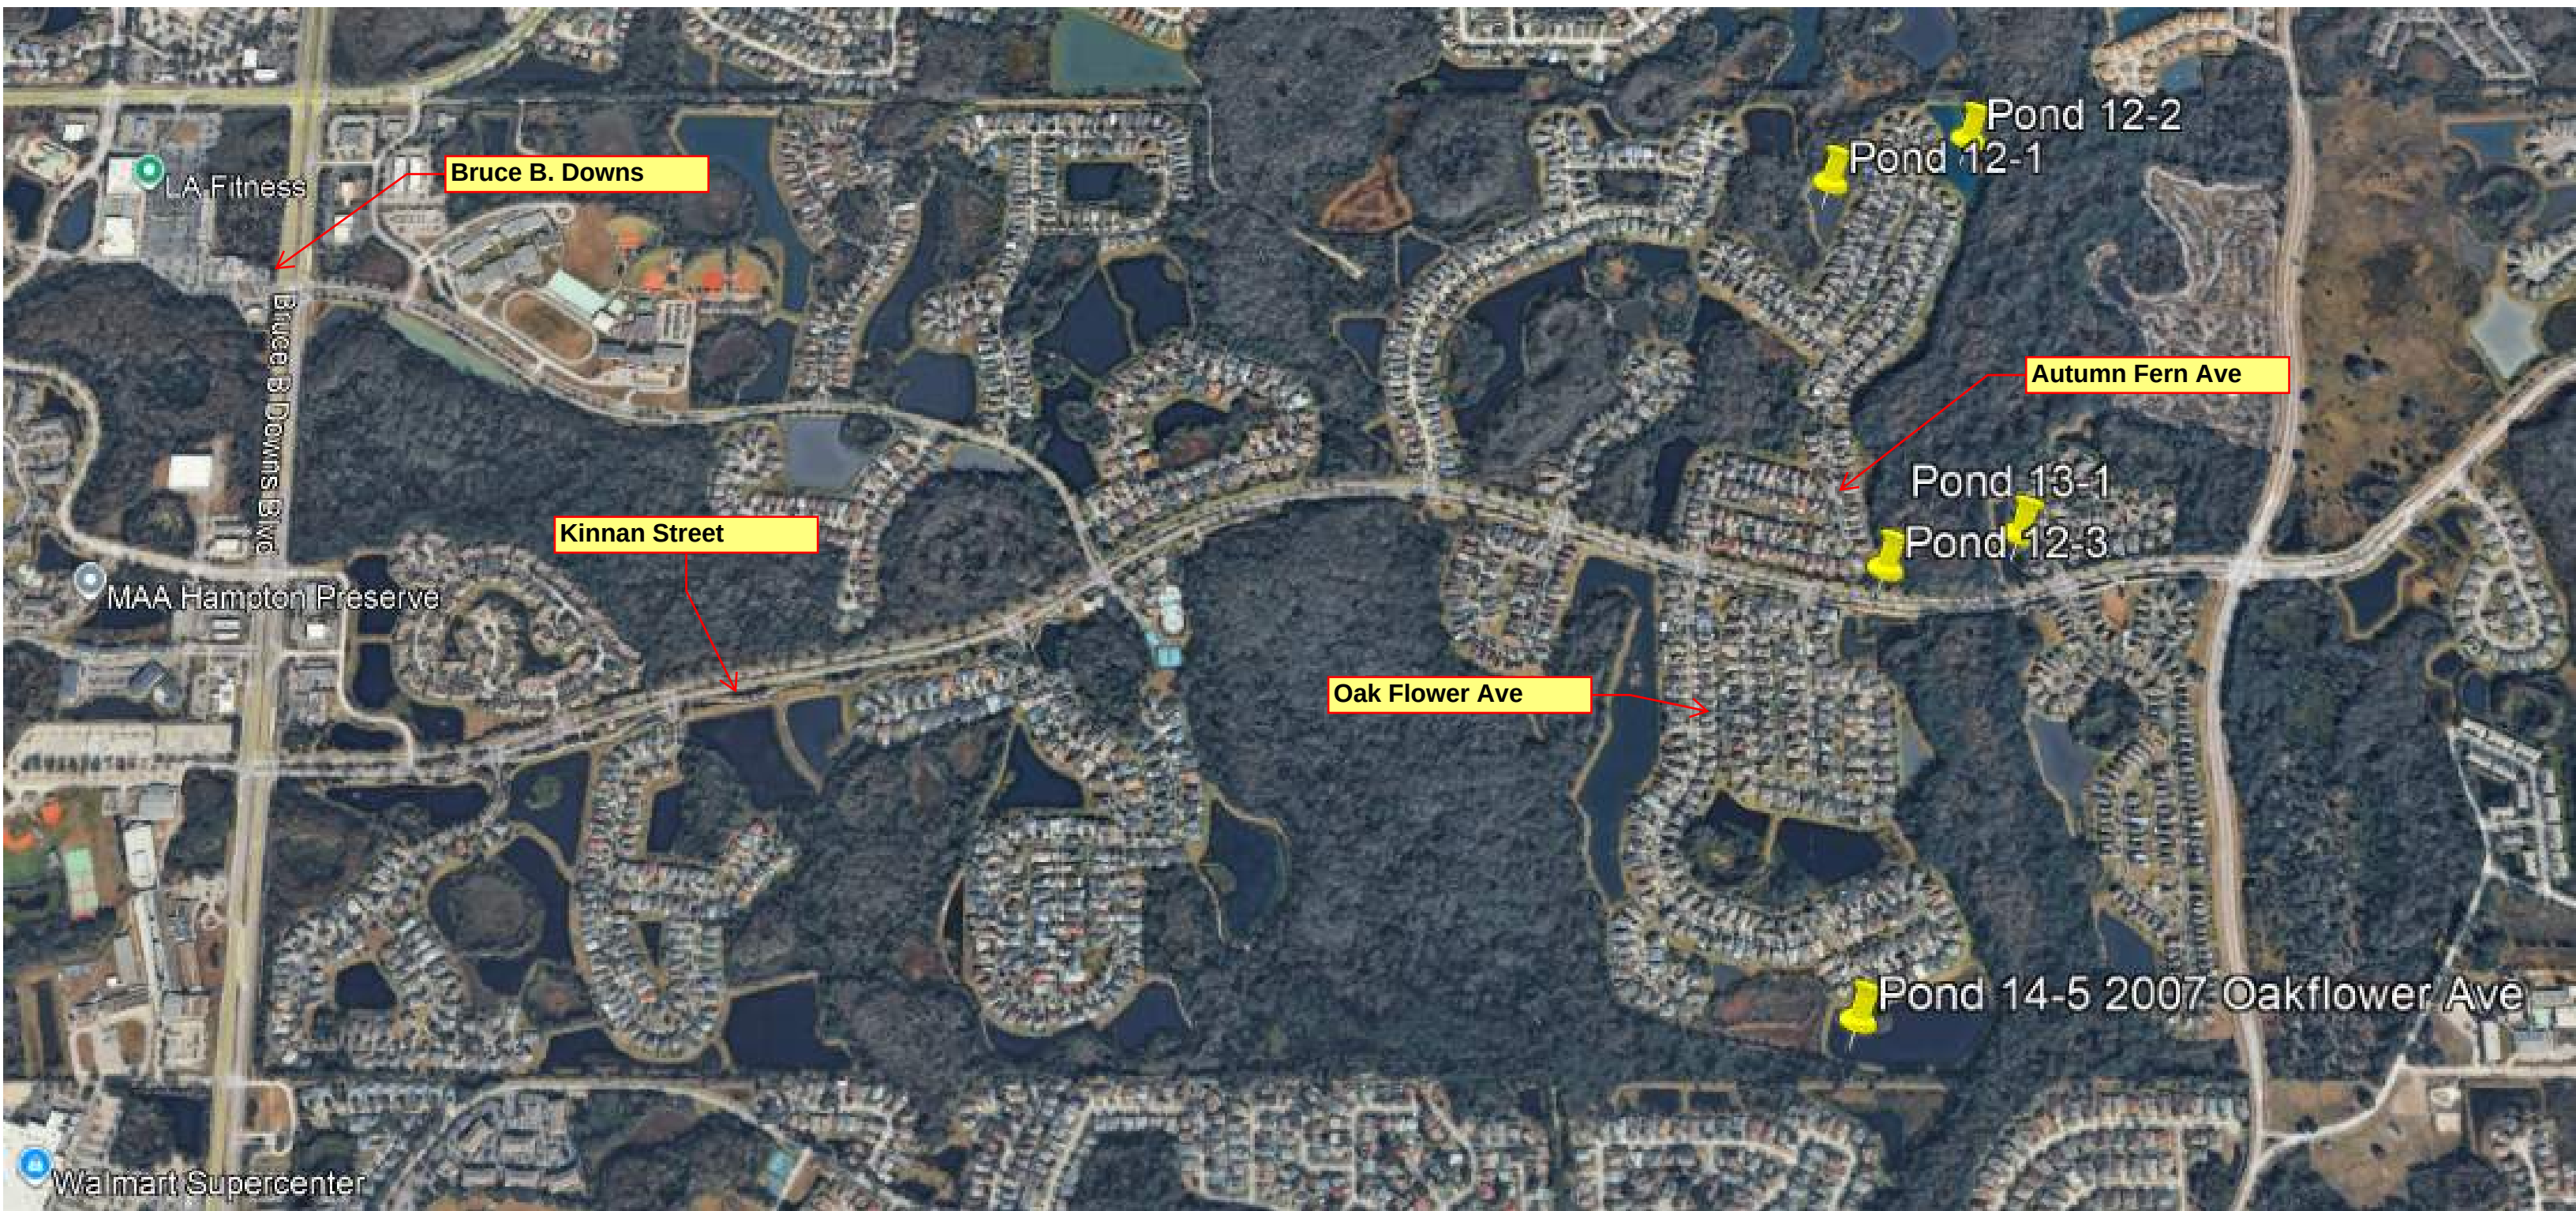
## Attachment 1: Live Oak Preserve Aerial

Eroded pond bank areas requiring repairs
